Tsuma-as Elementary Exterior Stairwell Repair and Maintenance

8 APPENDIX B: RJC REDACTED STRUCTURAL ASSESSMENT

RE: Tsuma-as Elementary School – Exterior Stairs Structural Assessment
5055 Compton Road, Port Alberni, BC

RJC No. NAN.142788.0002

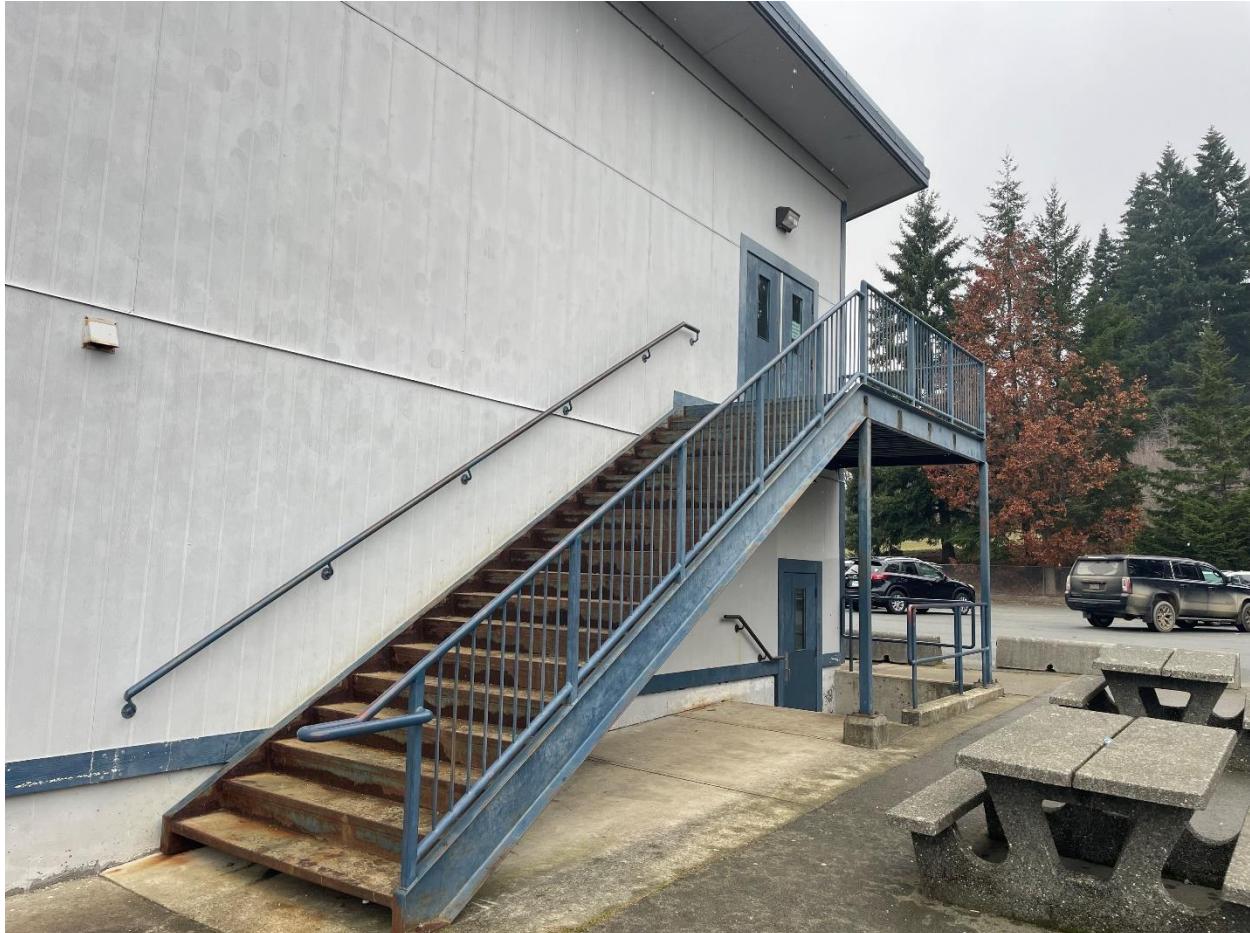
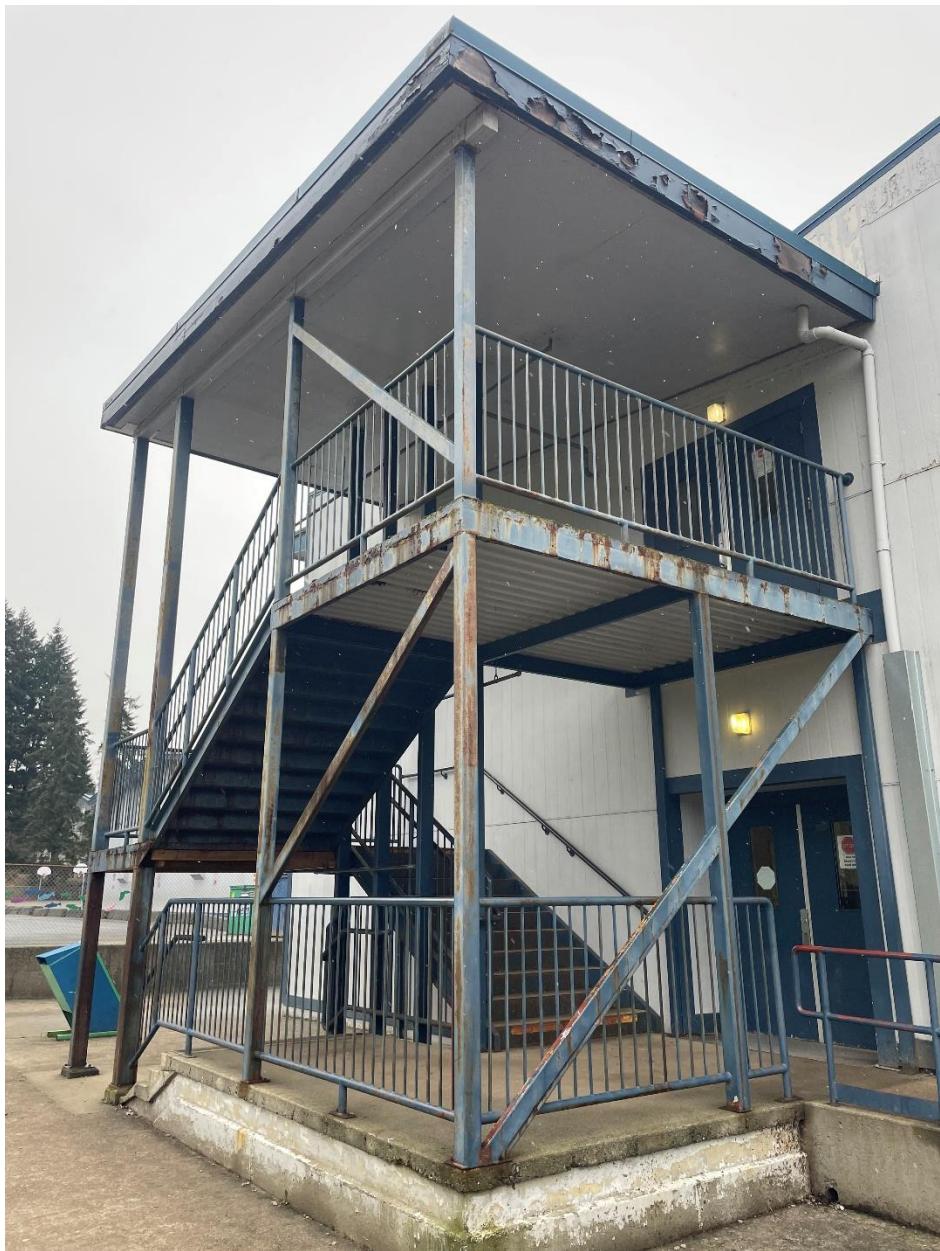
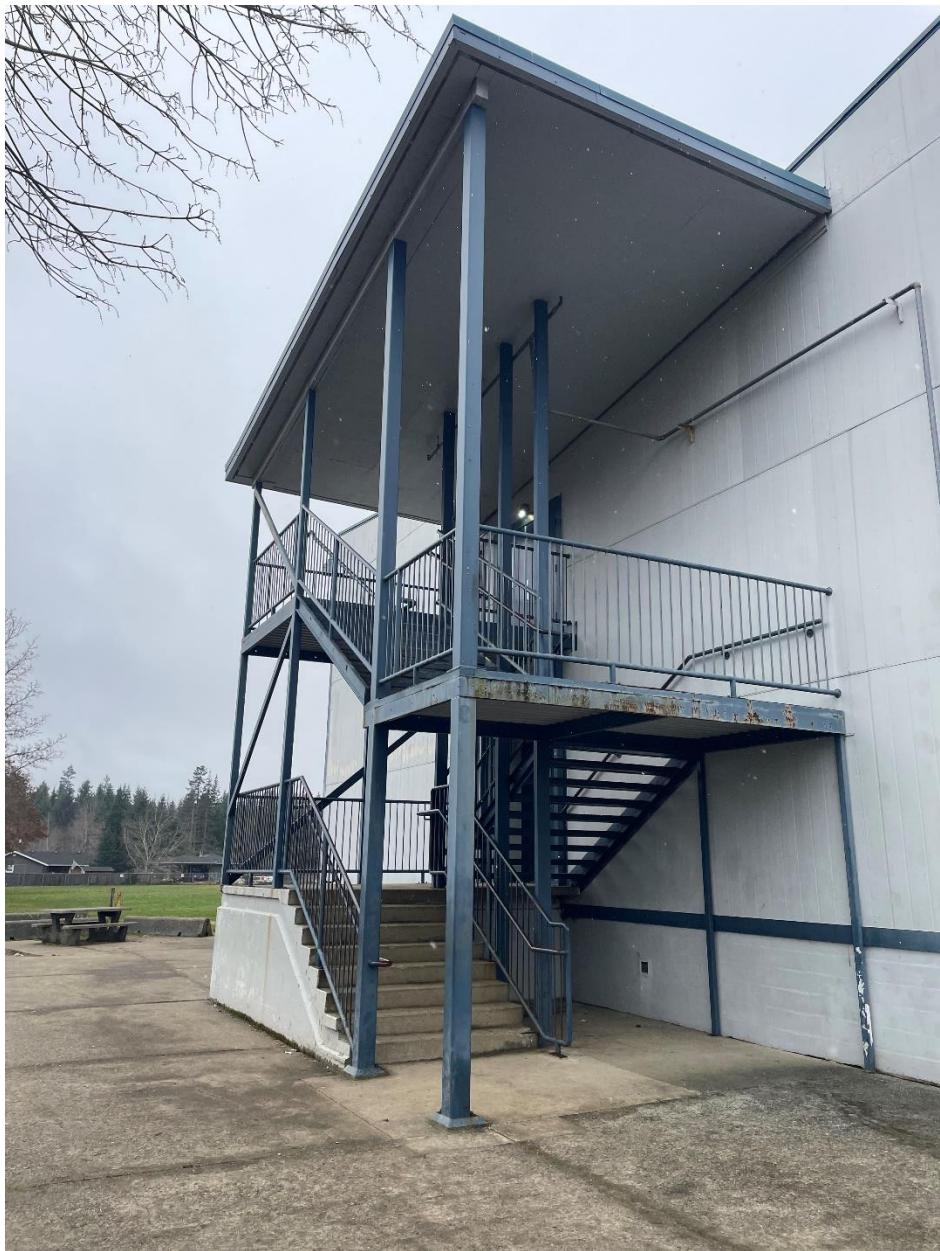
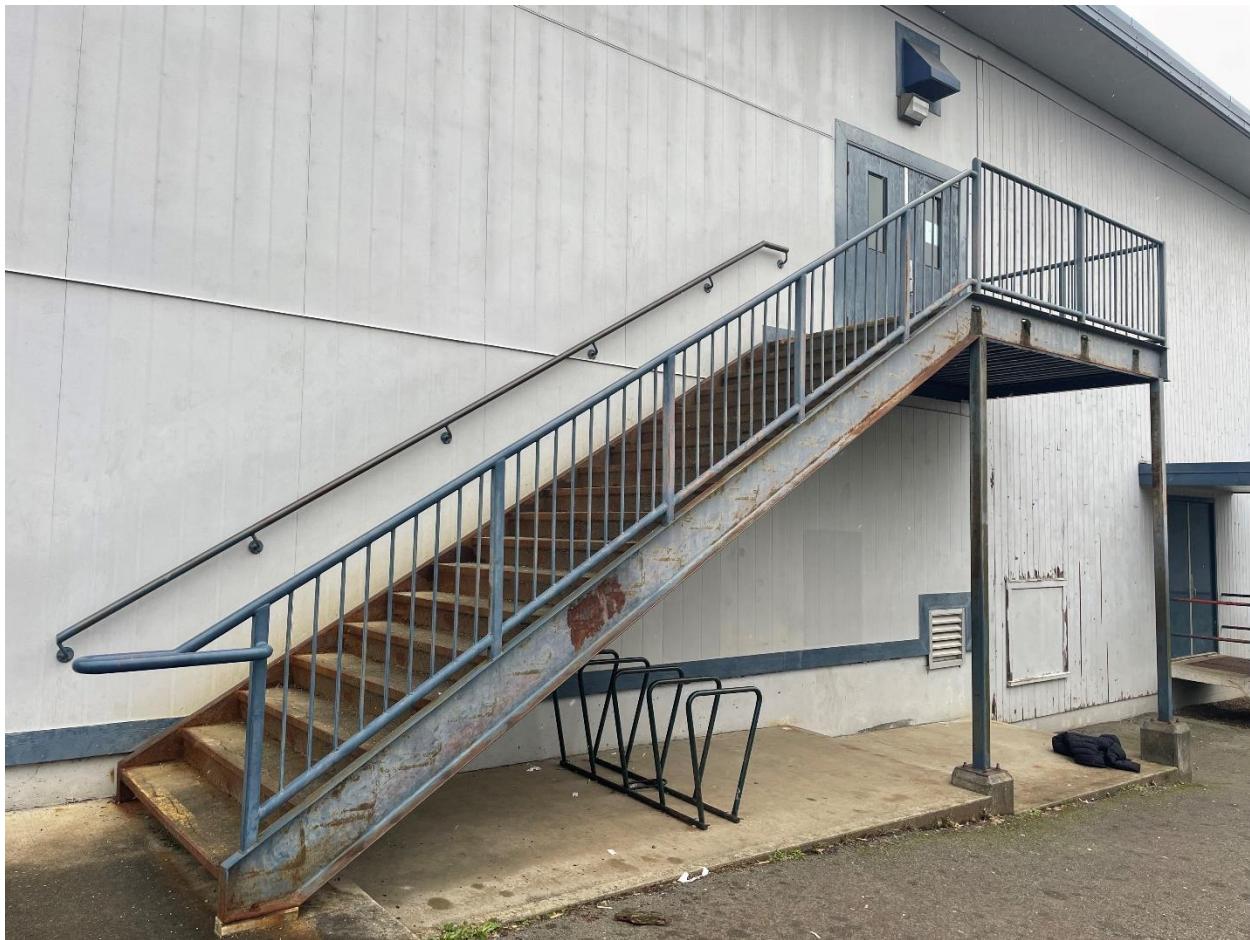
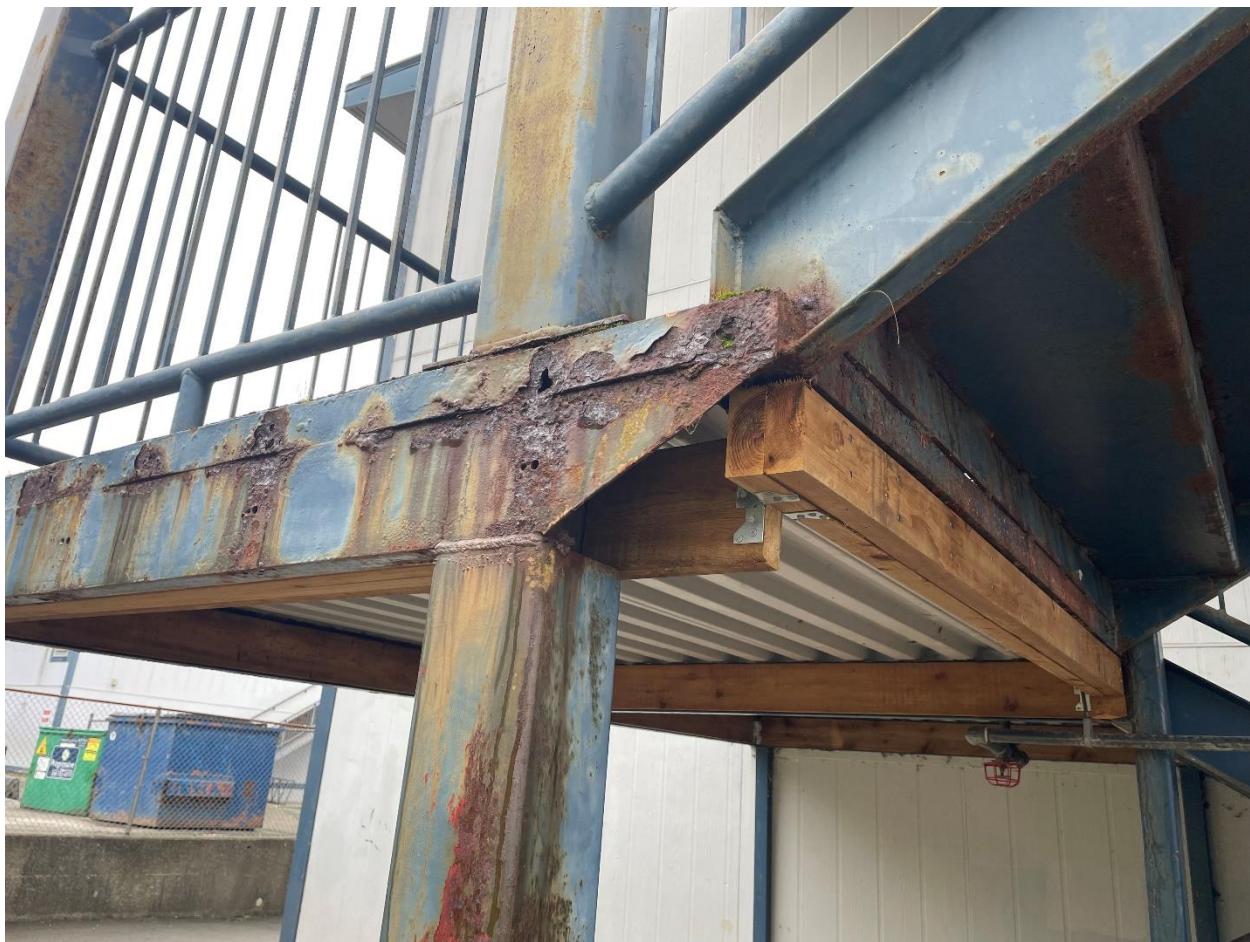
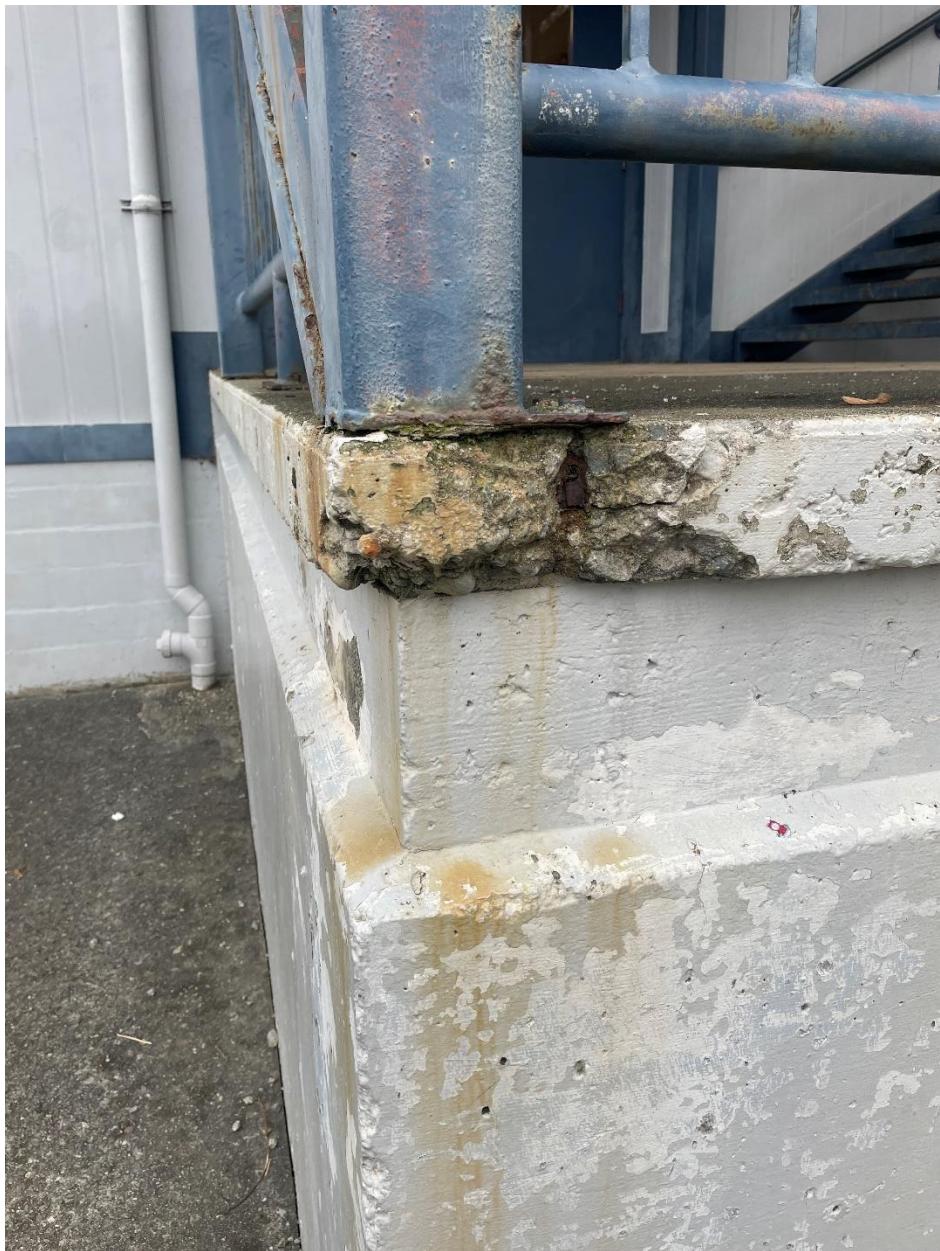
The pictures below highlight the four second floor exterior stairwells in the project scope with a few close-up pictures of some areas of concern.

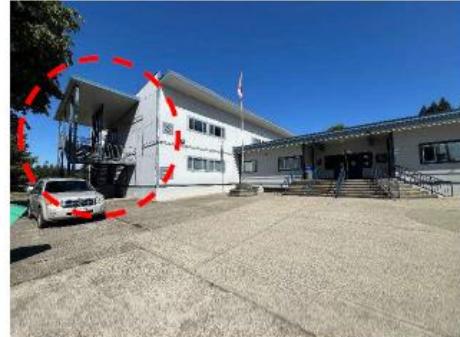
Photo 1 – Typical exterior stairs.

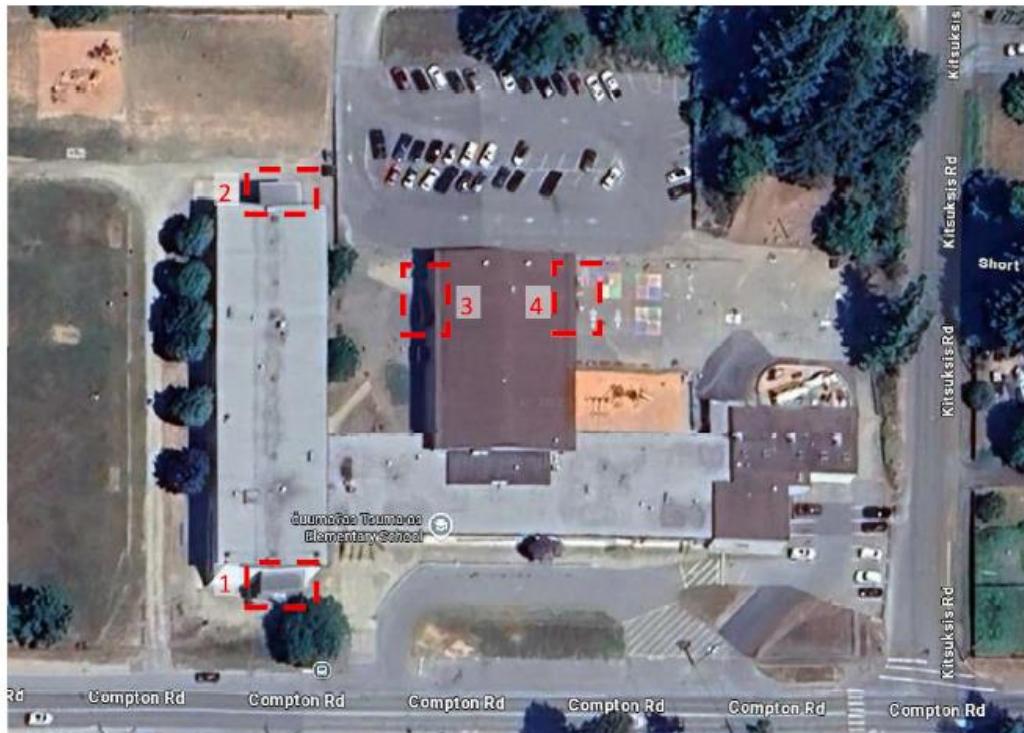
Tsuma-as Elementary School is an elementary school constructed circa 1975, with additions completed circa 1990 and 2011. Portions of the school are single storey, while others are two storeys and have exterior stairs installed for access and egress. The exterior stairs reviewed under this assessment are shown and labeled in Figure 1 for reference.

Figure 1 – Exterior stair plan.

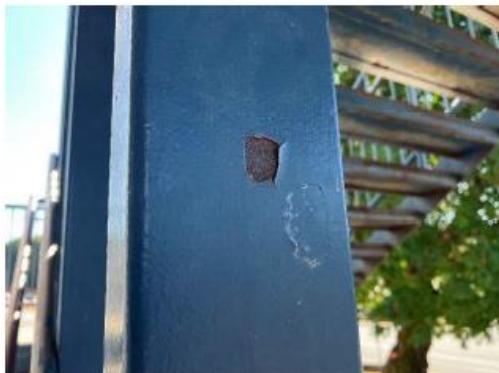
The concrete topping appears to be non-structural and is not coated, while the exposed steel framing is protected by a coating of paint. The observed paint appears to be faded and aged, with deficiencies such as scratches, gouges, chipping, and flaking observed, exposing steel below (see Photo 2).

Photo 2 – Damaged paint.

- **Recommendation 3:** Prepare and re-paint all stairs with high-performance MPI exterior paint system. Recommended timeline: 0 – 2 years.

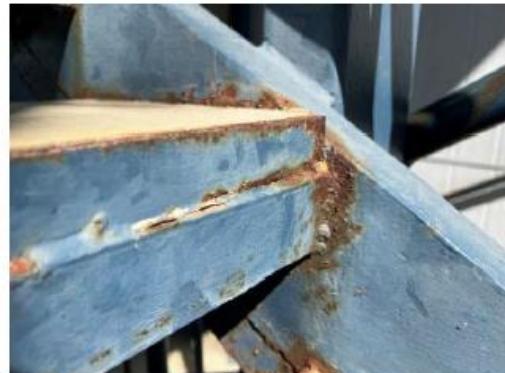
Targeted corrosion was observed consistently throughout the steel structure, including at locations of the paint deficiencies previously noted (see Photo 3). In general, the reviewed corrosion appeared to be superficial and relatively minor in severity, with little-to-no loss of steel cross section observed.

Photo 3 – Failing paint and corrosion.

- **Recommendation 2:** Complete targeted repairs to the steel stair structures. Recommended timeline: 0 – 2 years.

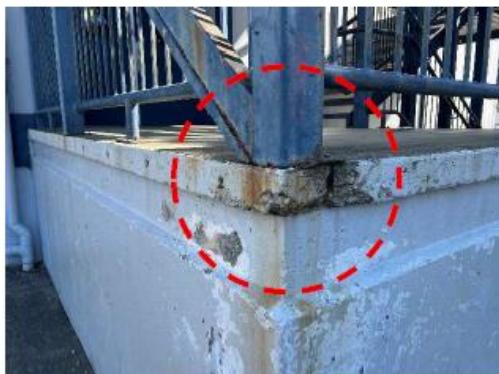
Deficiencies were observed in the grade-level concrete stairs and landing, including a damaged concrete slab edge at the corner of the landing (see Photo 4), which appears to be due to corrosion and subsequent expansion of the steel column baseplate anchors, as well as a delaminated stair nosing due to the corrosion of the embedded reinforcing (see Photo 5).

Photo 4 – Damaged stair landing slab edge.

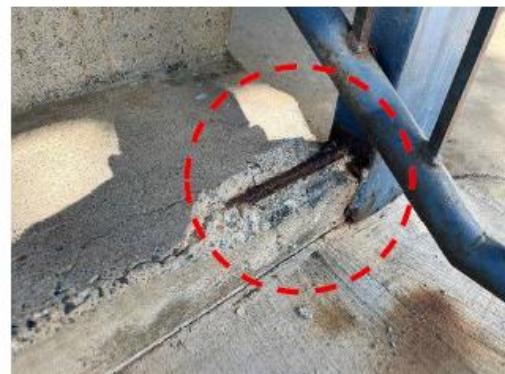
Photo 5 – Delaminated stair nosing.

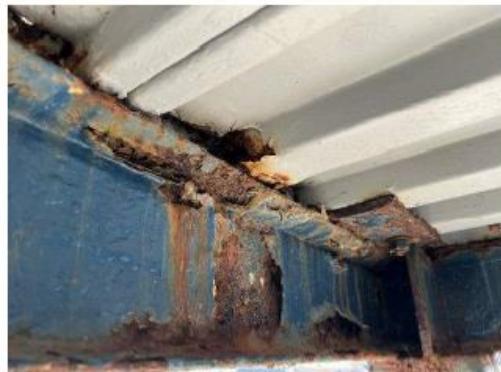
Stair 2 is located at the northwest corner of the school and is essentially identical in construction to Stair 1. In general, the reviewed stair structure appears to be performing as intended with no visible signs of distress or significant deflection, though notable corrosion and deterioration was observed. Stair 2 has similar deficiencies to those noted for Stair 1, with the notable difference being the severity of some of the localized steel corrosion (see Photos 6, 7, and 8).

Photo 6 – Advanced steel corrosion.

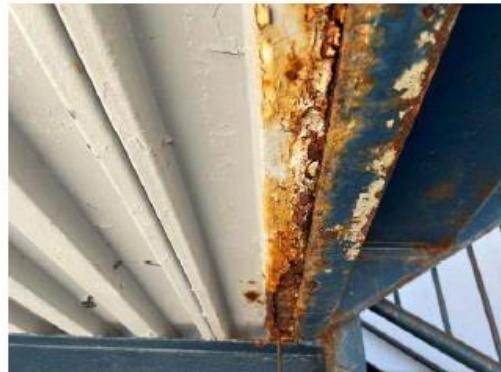
Photo 7 – Corroded steel framing and deck.

The most severe corrosion was observed on first suspended stair landing, where numerous primary structural elements are experiencing significant corrosion and localized loss of cross section. In select locations, this corrosion and cross-sectional loss has extended to connections such as shown in Photo 9.

- **Recommendation 1:** Install temporary shoring at first suspended stair landing at Stair 2.
Recommended timeline: Immediately.

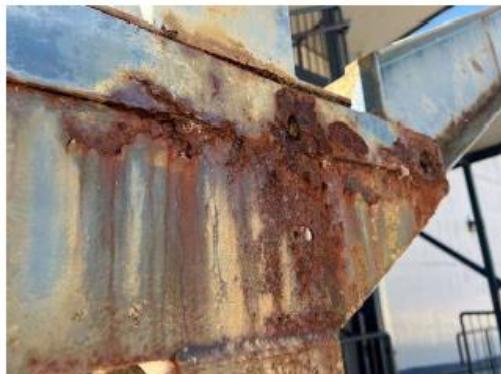
Photo 8 – Advanced steel corrosion.

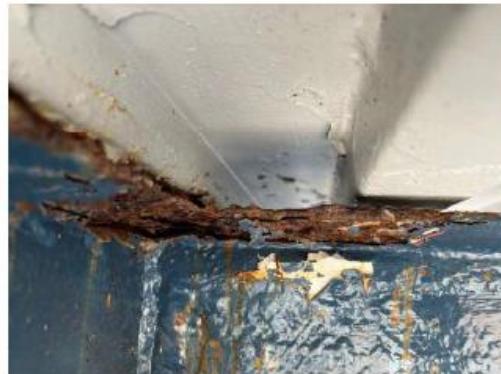
Photo 9 – Corroded steel connection.

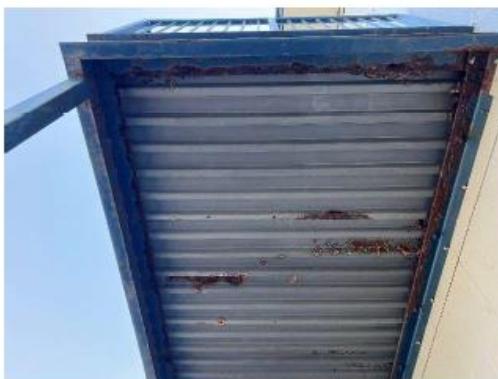
Stair 3 is an open-air stair structure on the north side of the school which is exposed to wind, rain, and snow. In general, the reviewed stair structure appears to be performing as intended with no visible signs of distress or significant deflection. In general, it is experiencing similar deficiencies to Stairs 1 and 2 such as aged and failing paint and targeted corrosion as shown in Photos 10 and 11. It should be noted that the corrosion levels observed on Stair 3 are not as severe as Stair 2 and no significant loss of cross section was observed.

Photo 10 – Targeted steel corrosion.

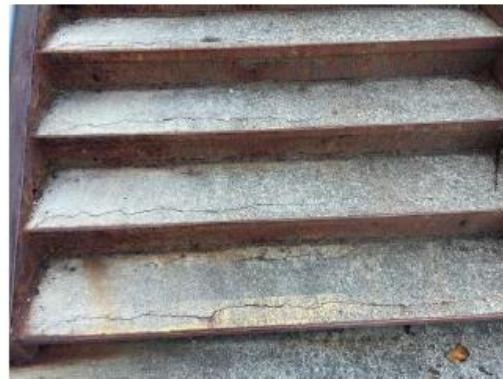
Photo 11 – Corroded steel stair risers.
